# APS Tech 101629 SCSI Connections Replacement

This guide gives instructions on how to remove the SCSI Ports on the APS Tech 101629 and then replace any that are faulty.

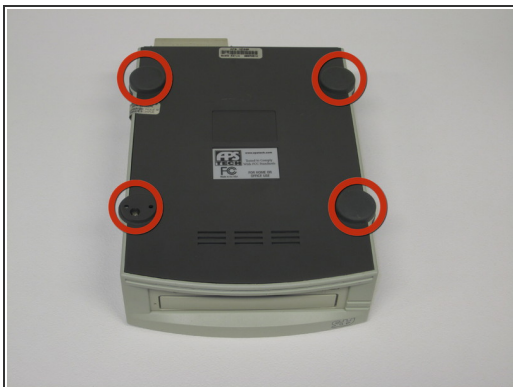
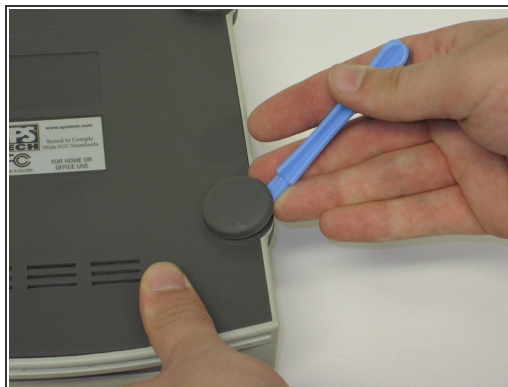
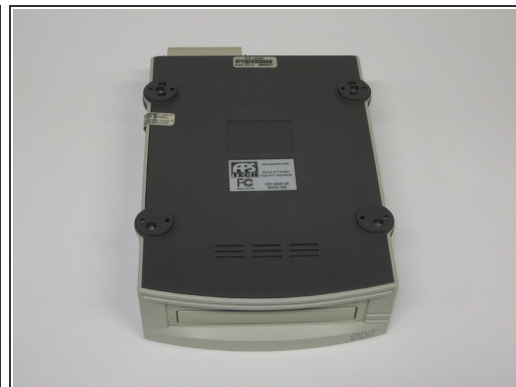
## Step 1 — External Casing

- Pry 4 plastic feet off the bottom of the enclosure using the iPod opening tool.

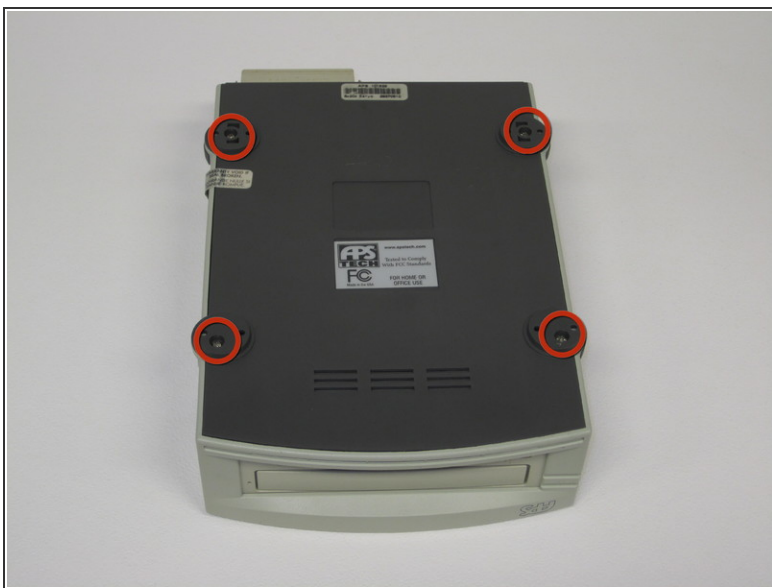
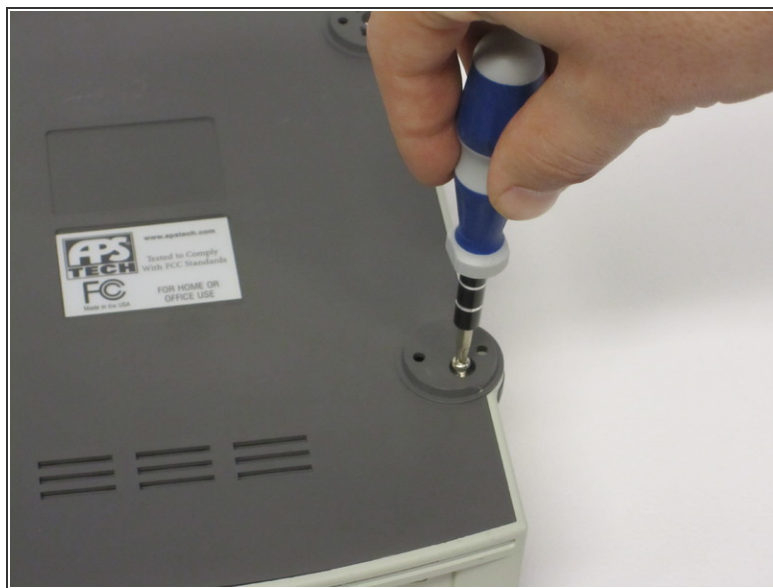
## Step 2

- Unscrew the four screws previously covered by the feet.

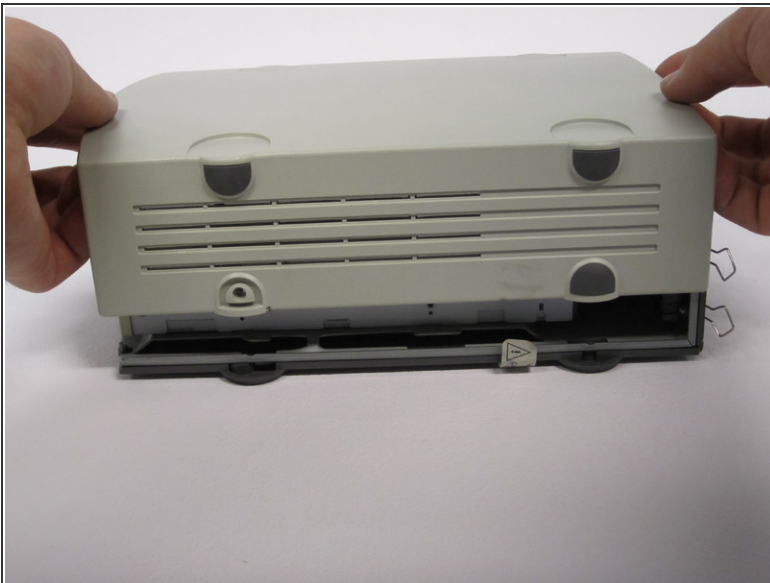
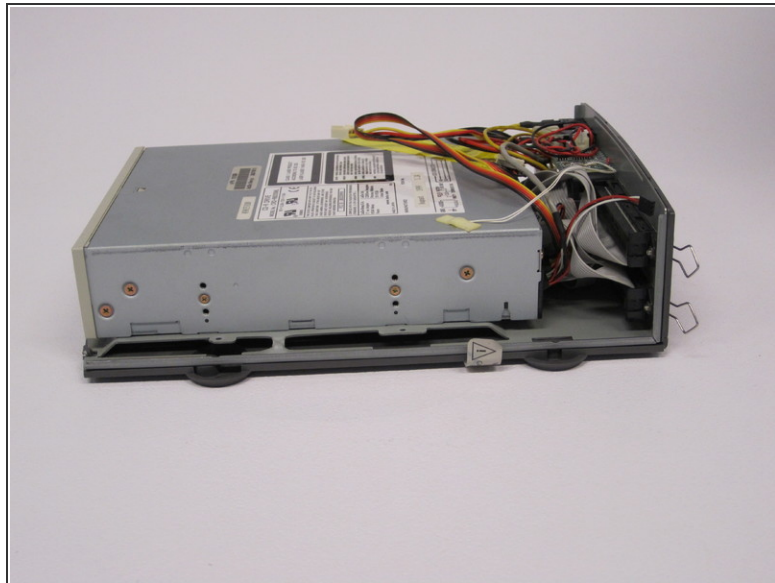
## Step 3

- Flip the device right side up, then gently slide the casing upwards and off the hard drive.

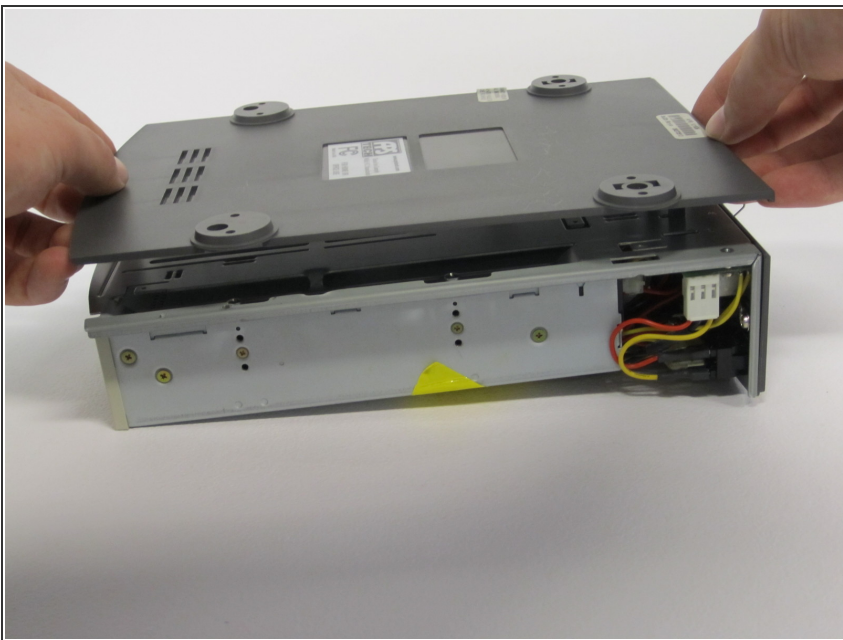
## Step 4

- Flip device upside down again.
- Gently pry the bottom gray casing away from the device.

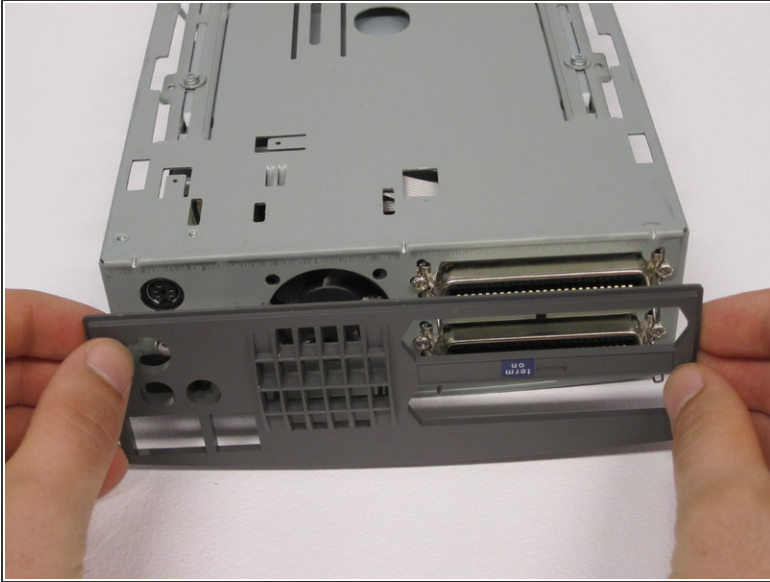
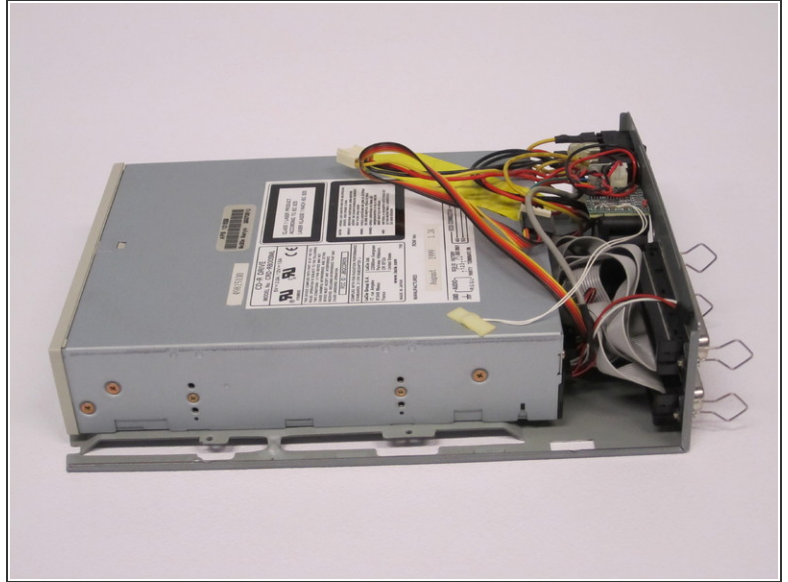
## Step 5

- Rotate so back of device is facing you, then gently pry the back casing away.
- When back casing is removed, the fan will become loose.

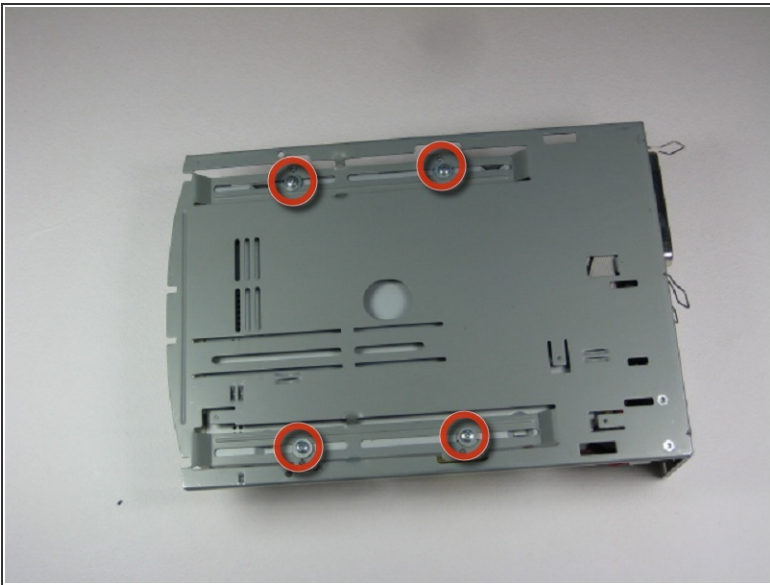
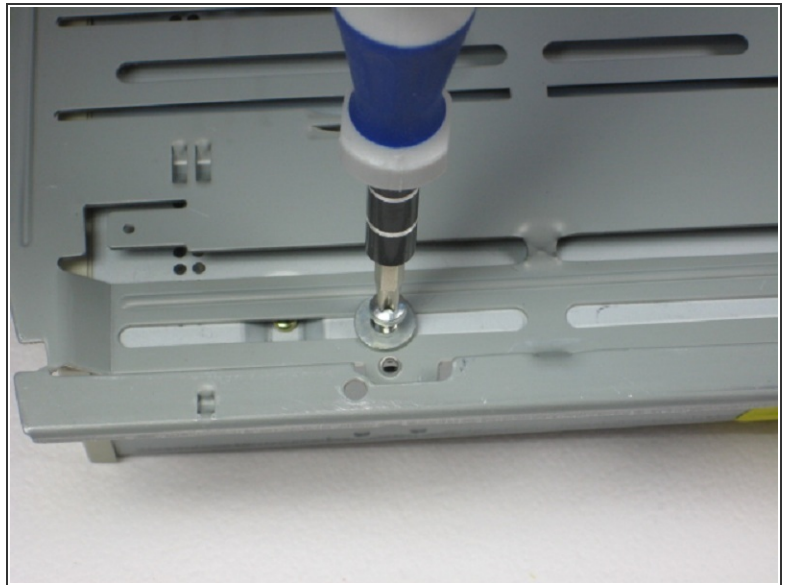
## Step 6 — Internal Drive Component

- Flip so device is upside down.
- Remove 4 screws with Phillips #1 screw driver.
- ⓘ Be sure to save the washers that separate the screws from the baseplate for reassembly.

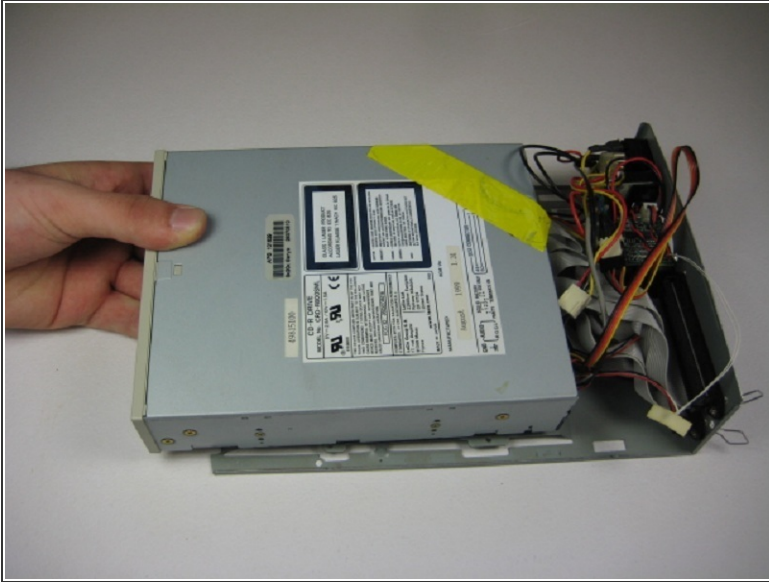
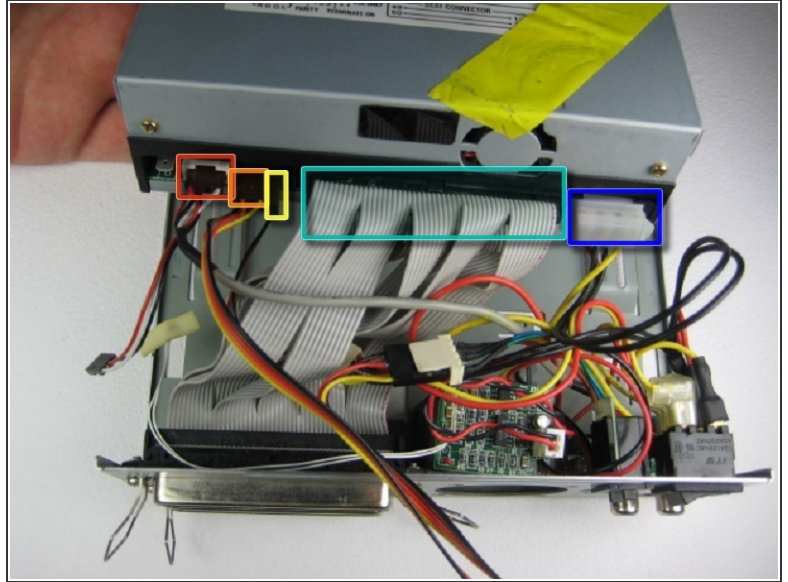
## Step 7

- Slide the internal drive component away from the back of the device.
- Remove the connections from the back of the internal component in the order of your choosing, we suggest left to right. The connections are:
  - Audio Connection
  - SCSI ID
  - Terminate On
  - SCSI Connection
  - DC Input (power)

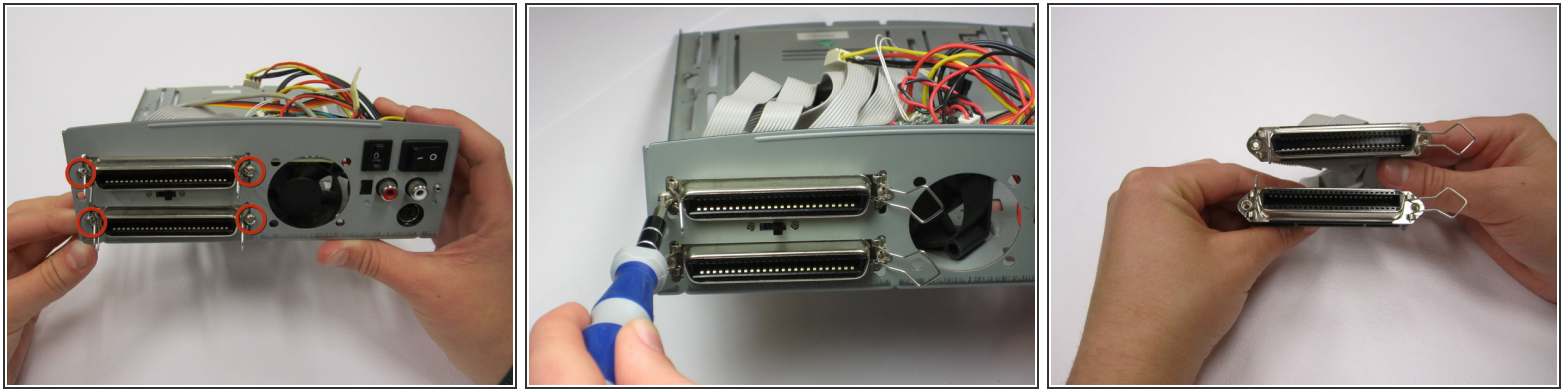
## Step 8 — SCSI Connections

- Remove the four Phillips #1 Screws from back panel.
- Once the screws are removed, the two connections are easily removed from the body.

To reassemble your device, follow these instructions in reverse order.
